SUBJECT: Update Report and Response to City Review Team Comments

RE: 1925 El Camino De La Luz, APN: 045-100-024
Santa Barbara, California

At your request, Cotton, Shires and Associates, Inc. (CSA) is providing you with this Update Geologic and Geotechnical Report (letter-report) to summarize the current site surface and subsurface conditions (Section 1). This report is intended to be an addendum to our Geologic and Geotechnical Investigation report, dated October 8, 2012. In this update report, we also respond to the geotechnical aspects of the City of Santa Barbara's Pre-Application Review Team Comments (Section 2) pertaining to 1925 El Camino De La Luz, dated August 9, 2013, and provide a summary of our review of the project plans (See attached Plan Review letter dated September 10, 2015).

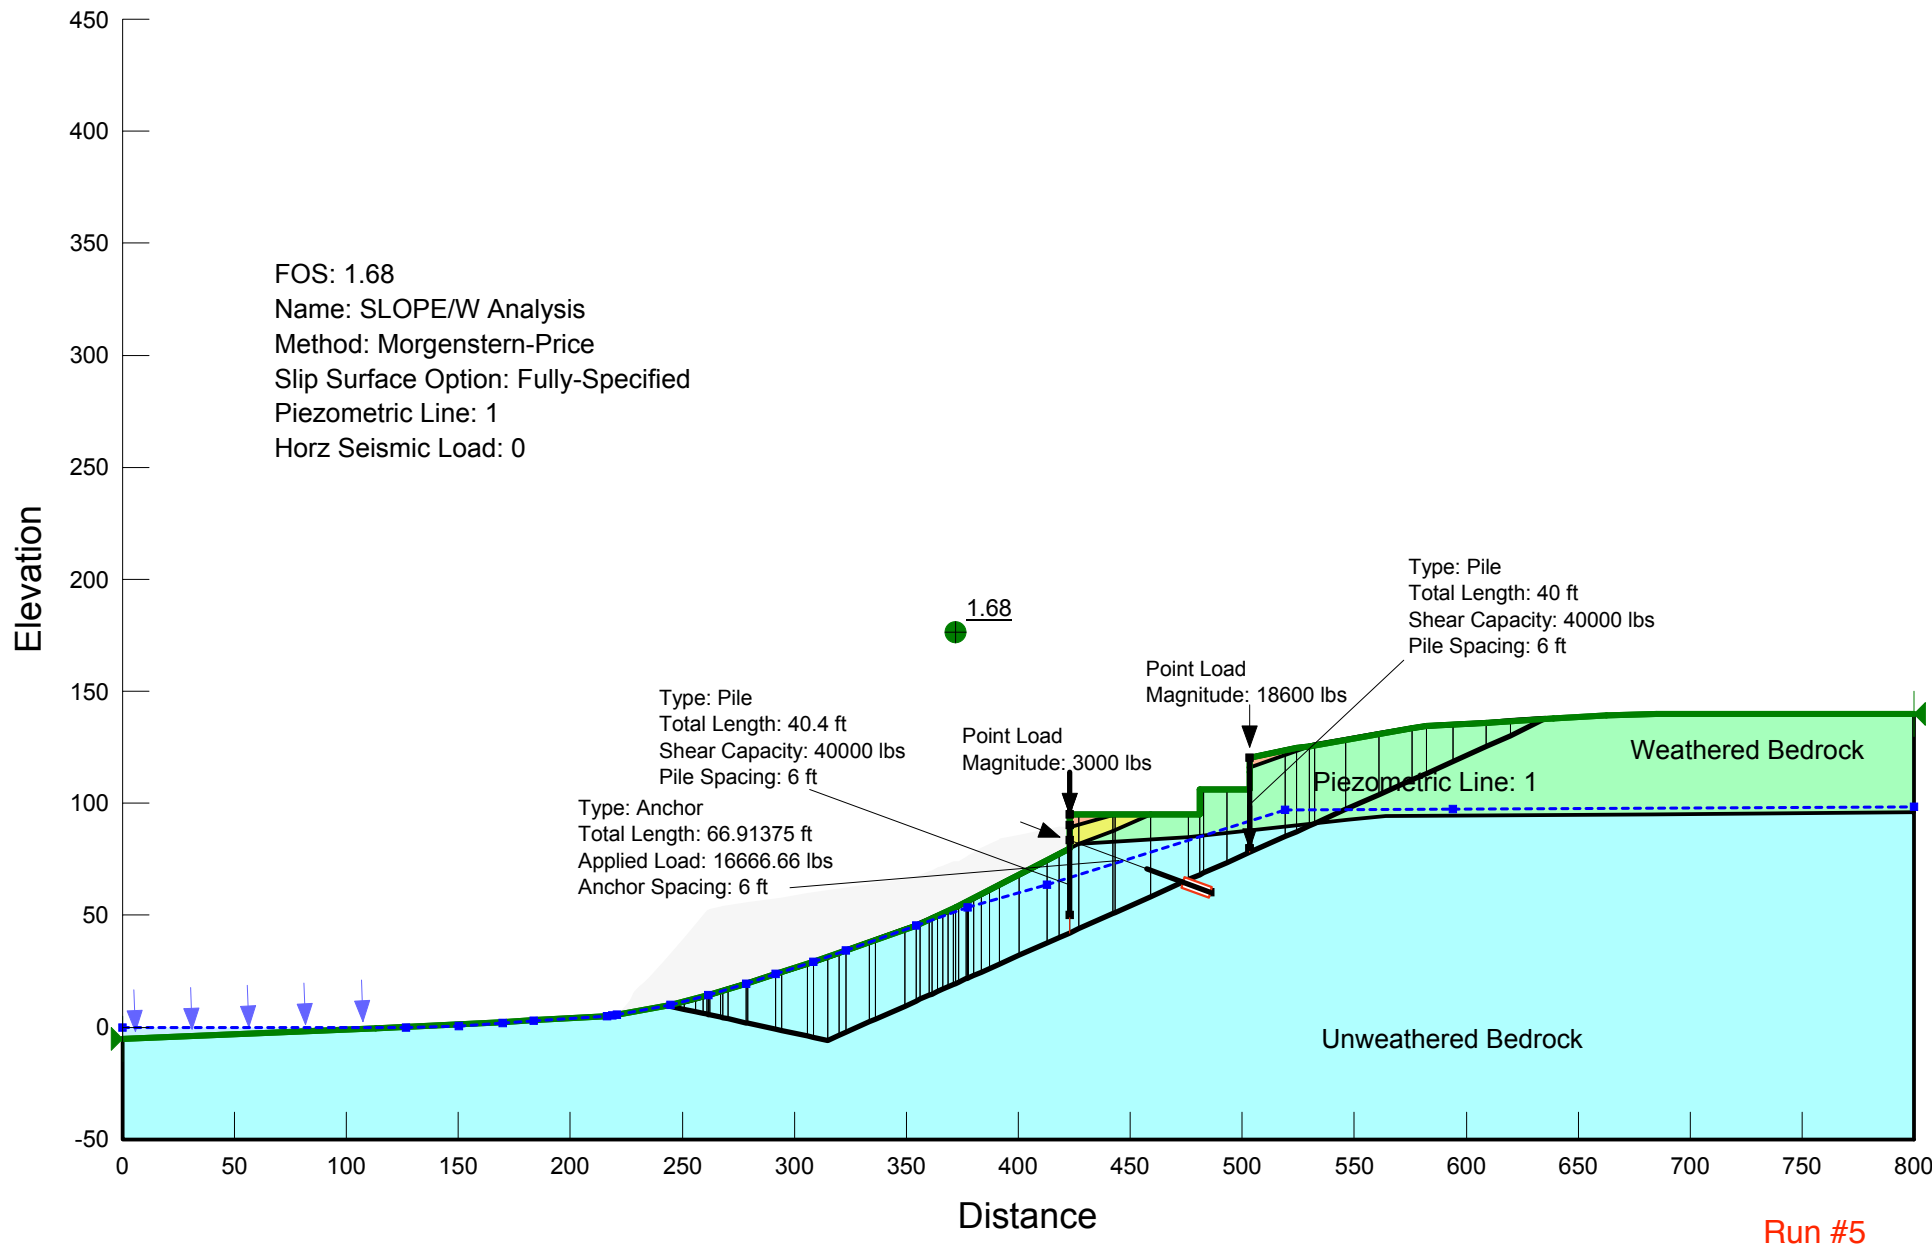
Name: Weathered Bedrock Unit Weight: 105 pcf Cohesion: 0 psf Phi: 25 ° Phi-Anisotropic Strength Fn.: Phi=45 (weathered)
Name: Unweathered Bedrock Unit Weight: 110 pcf Cohesion: 1 psf Phi: 32 ° C-Anisotropic Strength Fn.: X-bed Cohesion (Unweathered)=2000 Phi-Anisotropic Strength Fn.: Phi=40 (unweathered)
Name: Landslide Debris Unit Weight: 89 pcf Cohesion: 0 psf Phi: 19 °
Name: Af Unit Weight: 105 pcf Cohesion: 0 psf Phi: 25 °

Additional slope stability analyses were conducted on Slope Stability Section A-A' to estimate the approximate location of a potential failure surface with a Factor of Safety of 1.5. Two scenarios were considered: 1) the existing landslide in-place (current condition), and 2) the theoretical condition where the landslide is evacuated (conservatively not relied upon for any buttressing effect). The computer program,

material properties, method of analysis were the same as used previously and summarized in the October 2012 report. For the current analyses, the minimum slide surface depth was restricted to 10 feet to ignore shallow surficial potential failure surfaces and a block search method was used. The results indicate that for the landslide in-place (current conditions), the minimum Factor of Safety for the conditions analyzed was $FS = 2.16$.

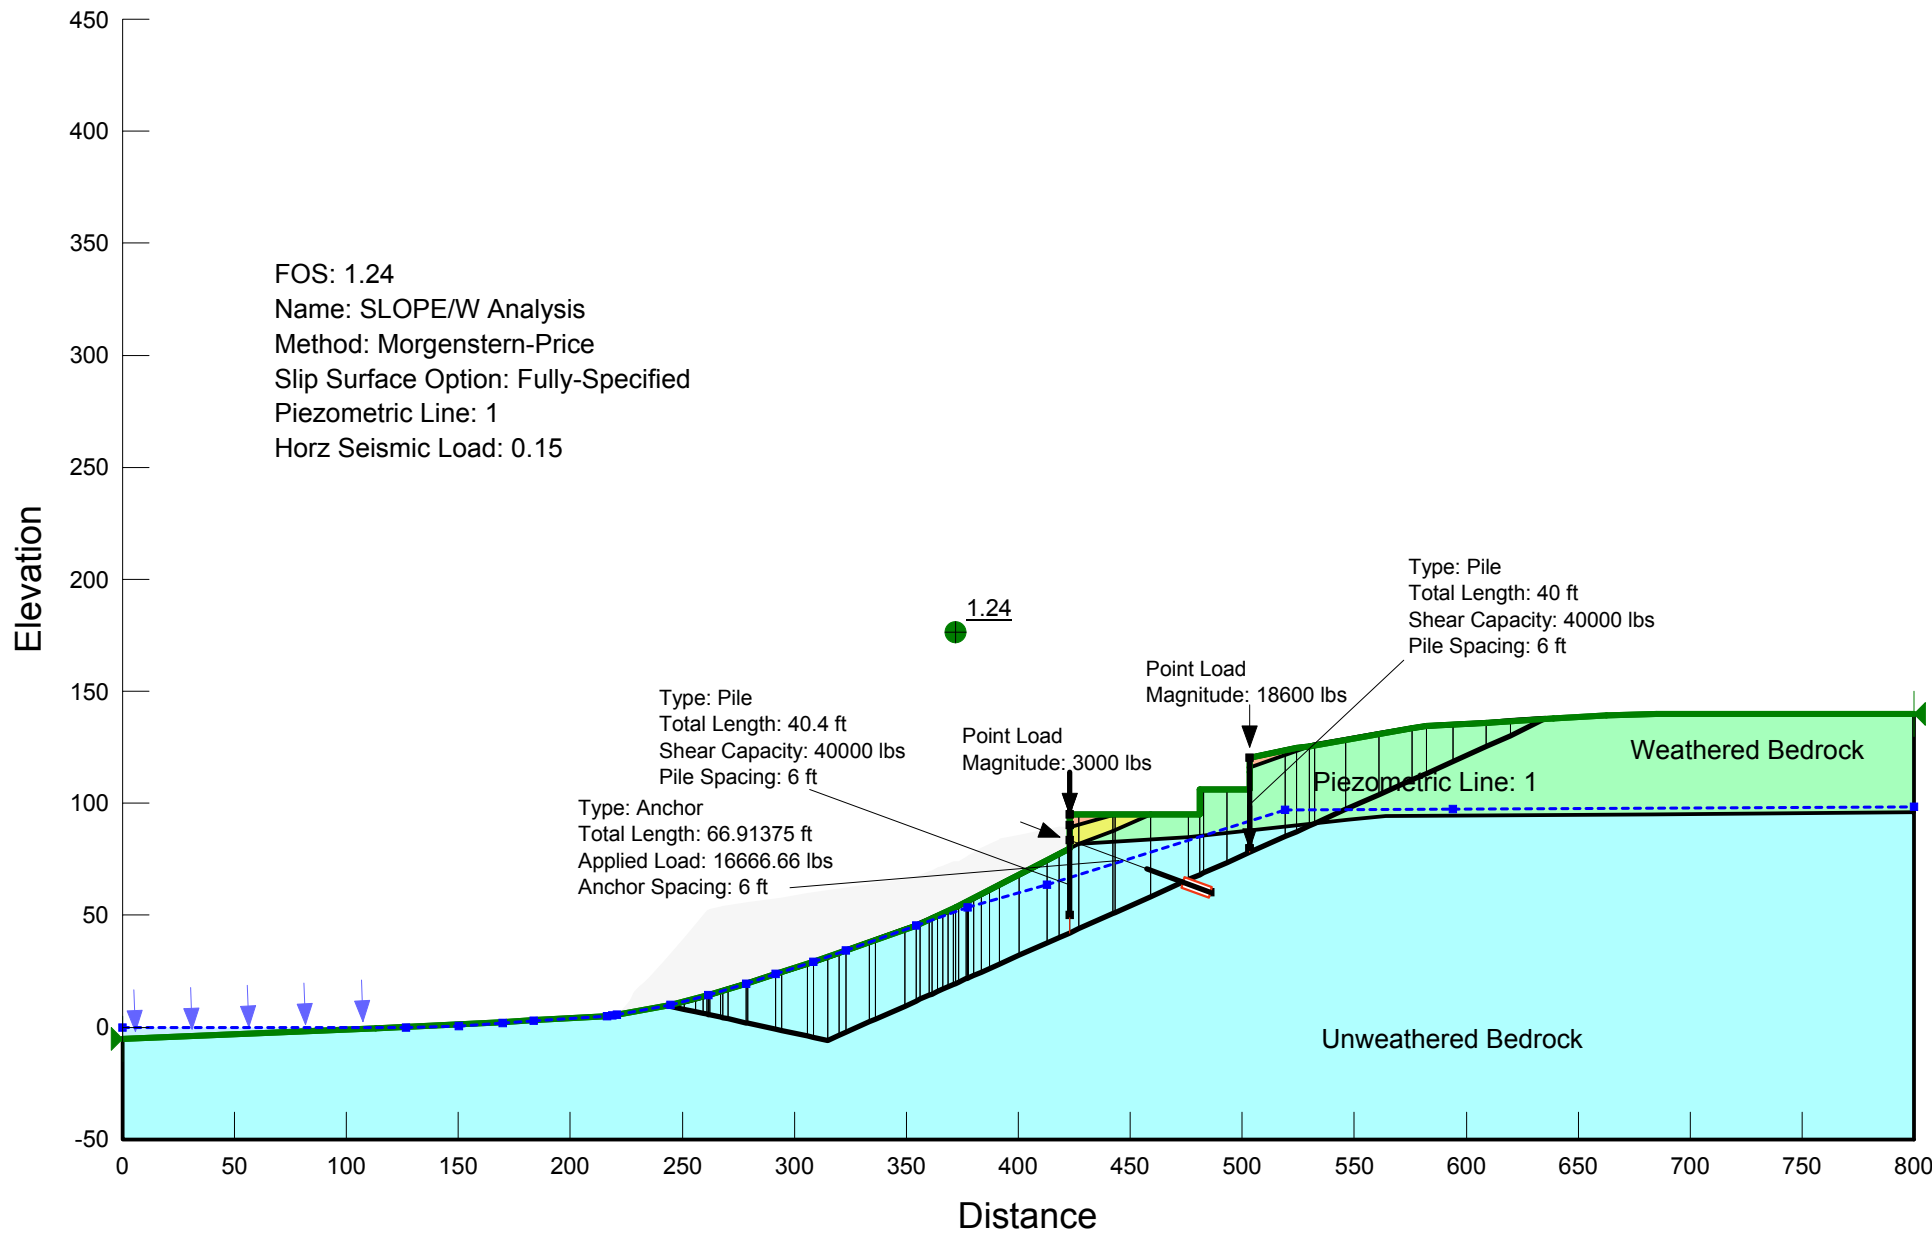
Name: Weathered Bedrock Unit Weight: 105 pcf Cohesion: 0 psf Phi: 25 ° Phi-Anisotropic Strength Fn.: Phi=45 (weathered)
Name: Unweathered Bedrock Unit Weight: 110 pcf Cohesion: 1 psf Phi: 32 ° C-Anisotropic Strength Fn.: X-bed Cohesion (Unweathered)=2000 Phi-Anisotropic Strength Fn.: Phi=40 (unweathered)
Name: Landslide Debris Unit Weight: 89 pcf Cohesion: 0 psf Phi: 19 °
Name: Af Unit Weight: 105 pcf Cohesion: 0 psf Phi: 25 °

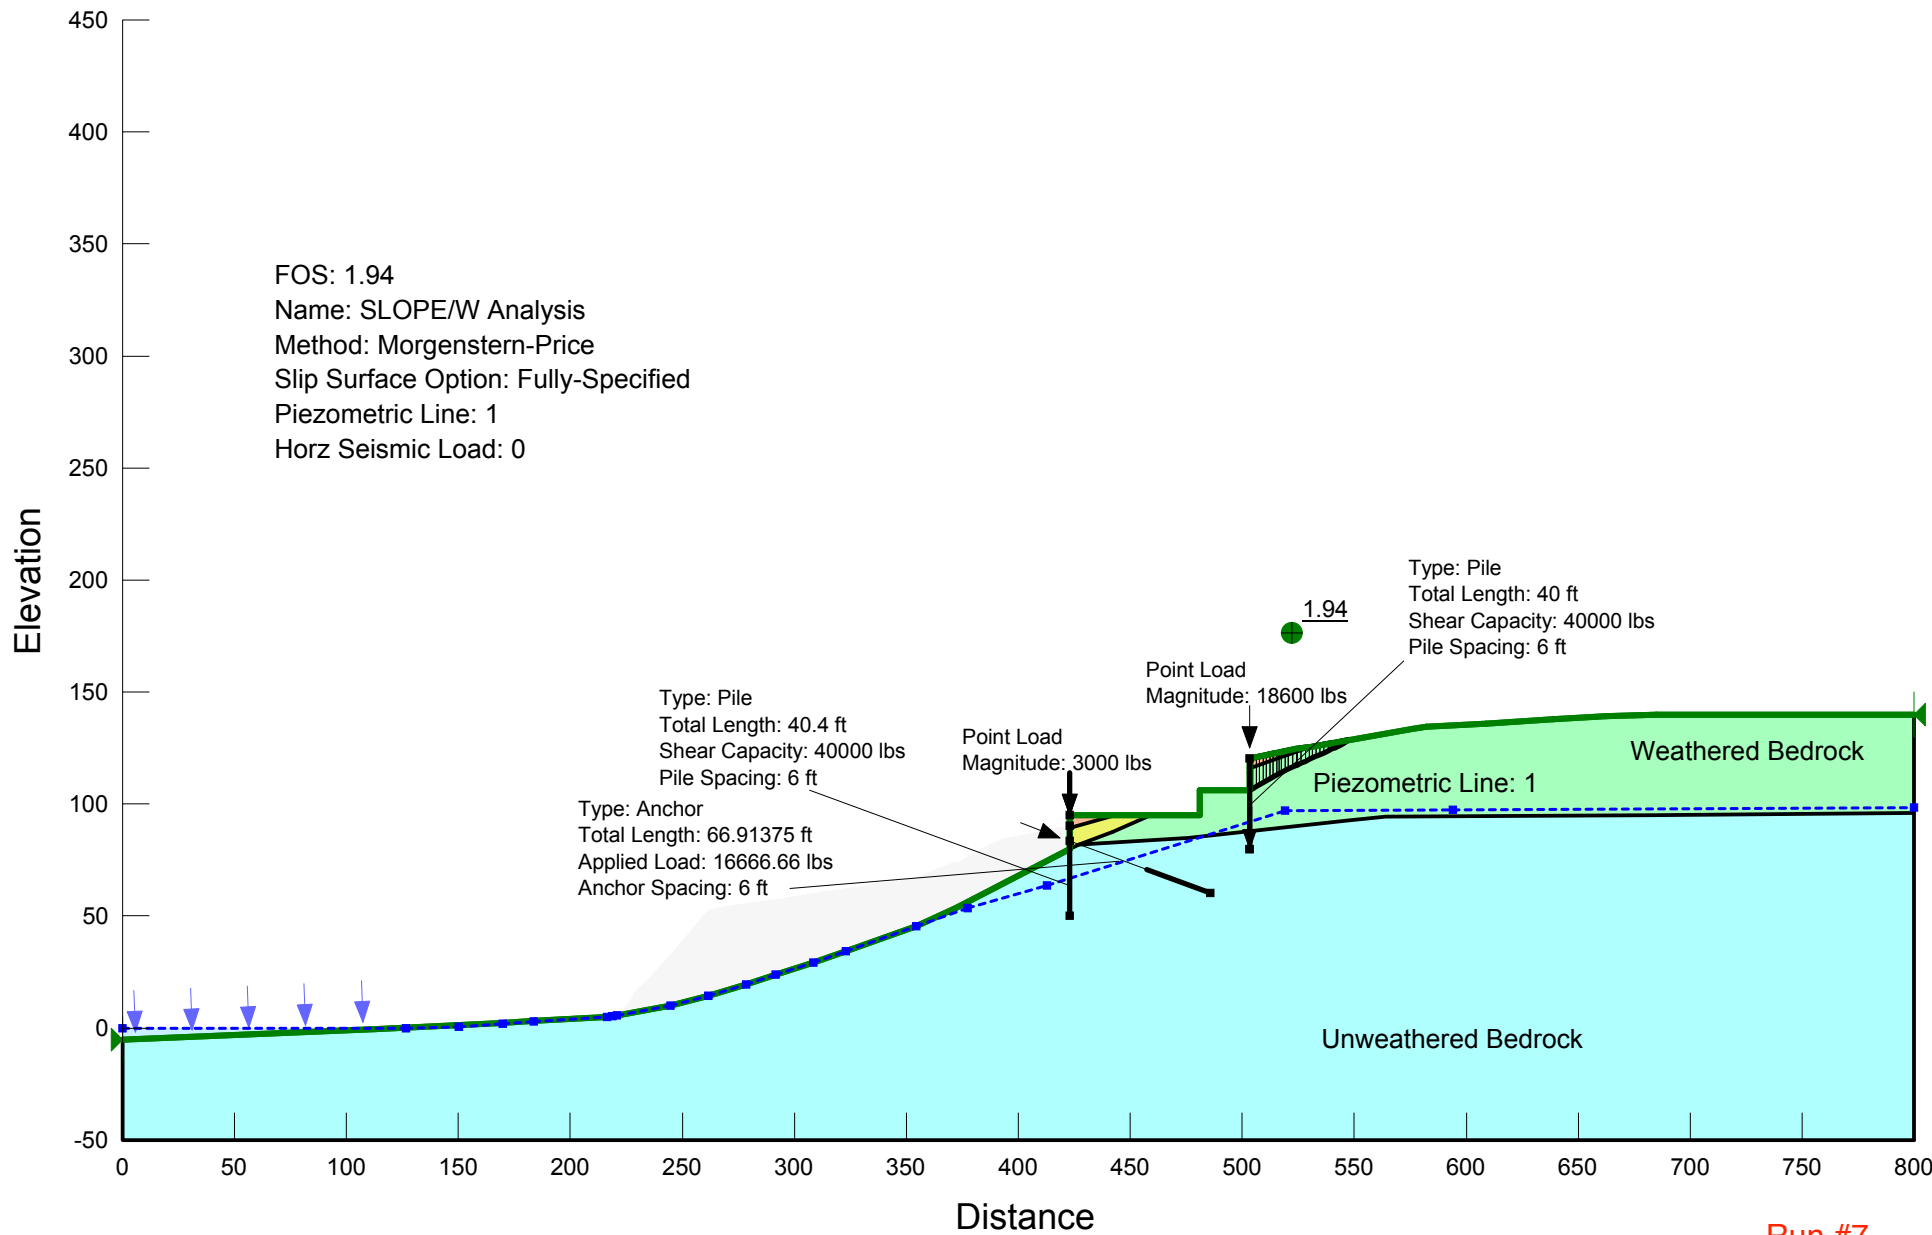
Name: Weathered Bedrock Unit Weight: 105 pcf Cohesion: 0 psf Phi: 25 ° Phi-Anisotropic Strength Fn.: Phi=45 (weathered)
Name: Unweathered Bedrock Unit Weight: 110 pcf Cohesion: 1 psf Phi: 32 ° C-Anisotropic Strength Fn.: X-bed Cohesion (Unweathered)=2000 Phi-Anisotropic Strength Fn.: Phi=40 (unweathered)
Name: Landslide Debris Unit Weight: 89 pcf Cohesion: 0 psf Phi: 19 °
Name: Af Unit Weight: 105 pcf Cohesion: 0 psf Phi: 25 °

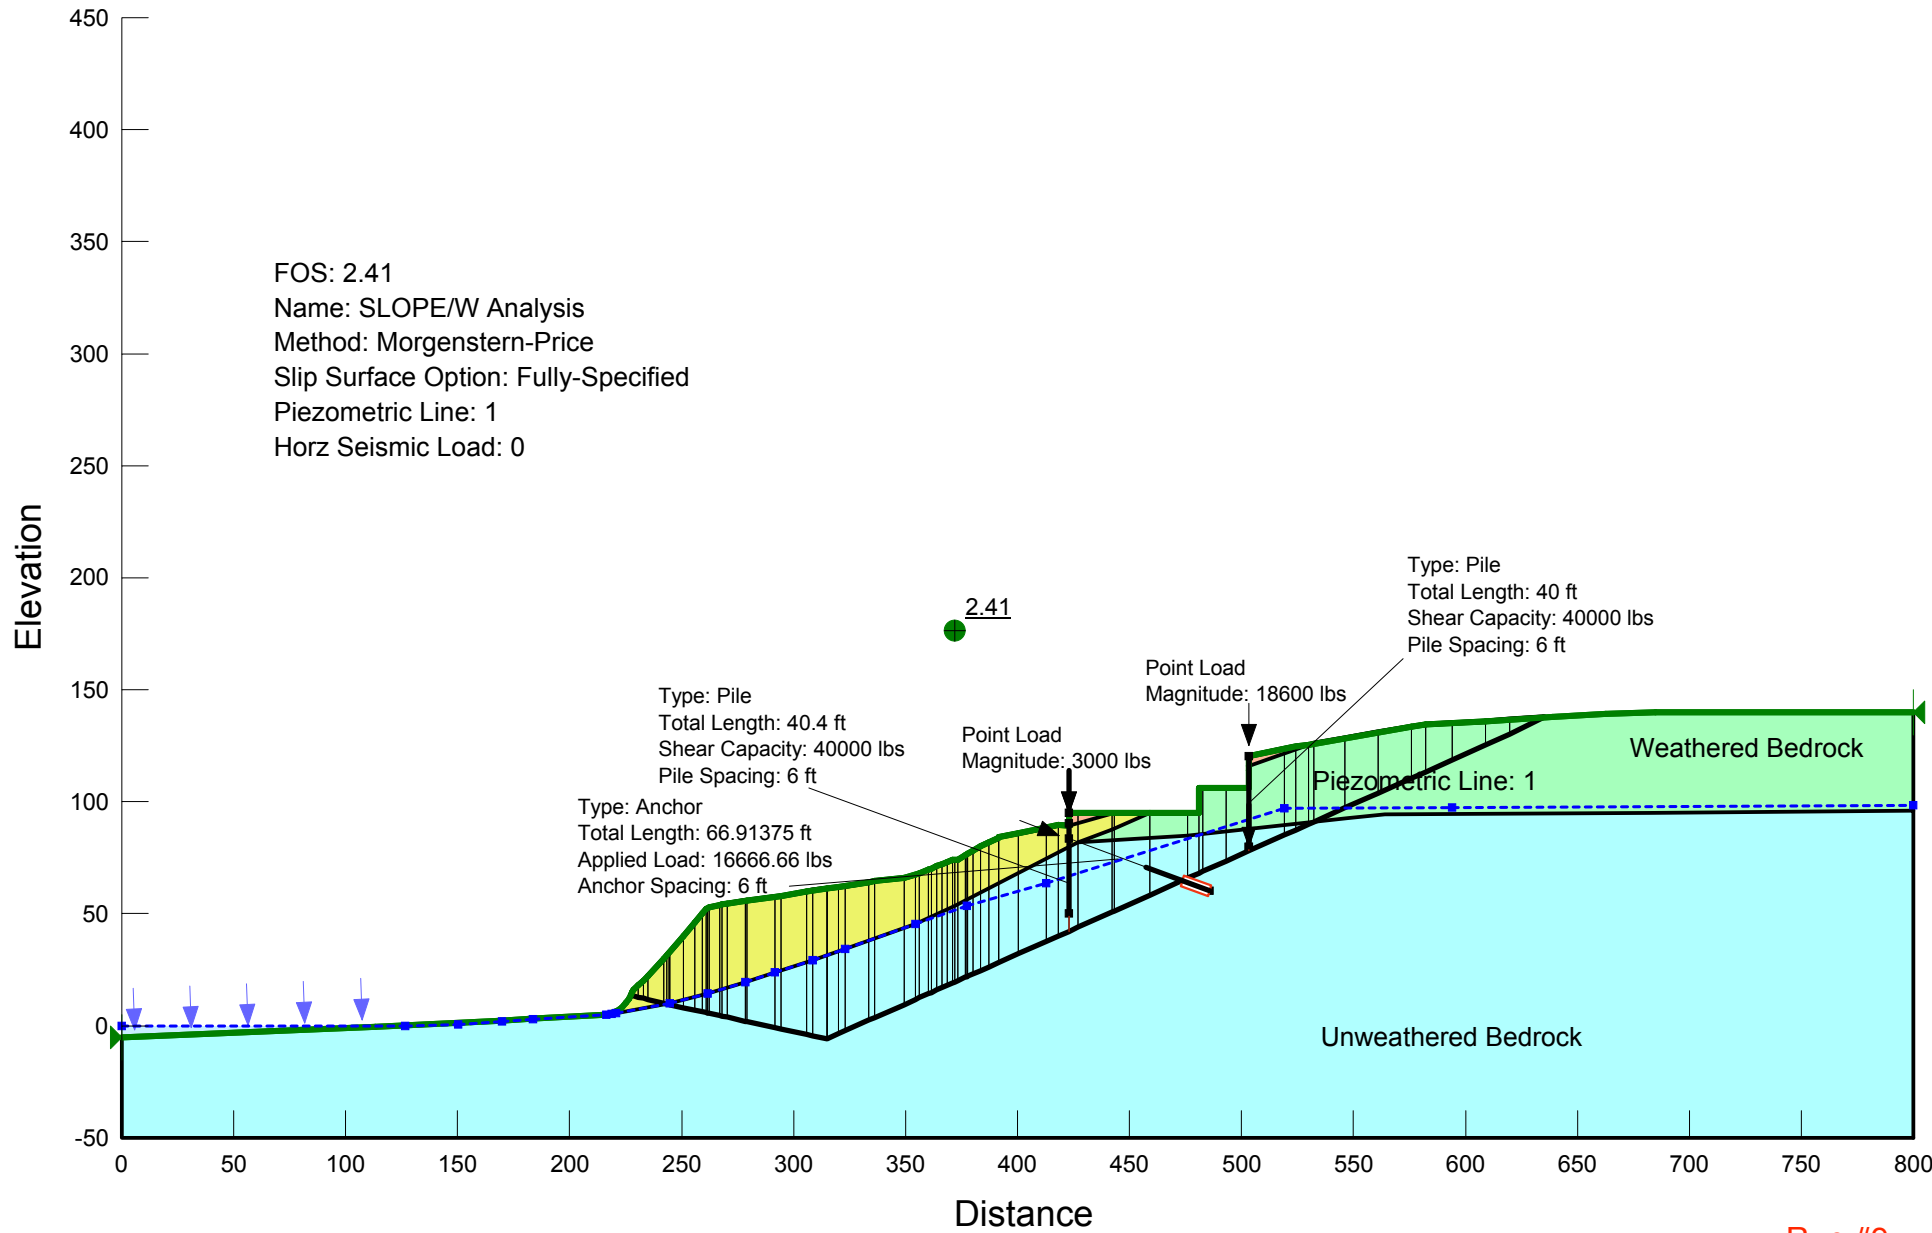
Name: Weathered Bedrock Unit Weight: 105 pcf Cohesion: 0 psf Phi: 25 ° Phi-Anisotropic Strength Fn.: Phi=45 (weathered)
Name: Unweathered Bedrock Unit Weight: 110 pcf Cohesion: 1 psf Phi: 32 ° C-Anisotropic Strength Fn.: X-bed Cohesion (Unweathered)=2000 Phi-Anisotropic Strength Fn.: Phi=40 (unweathered)
Name: Landslide Debris Unit Weight: 89 pcf Cohesion: 0 psf Phi: 19 °
Name: Af Unit Weight: 105 pcf Cohesion: 0 psf Phi: 25 °

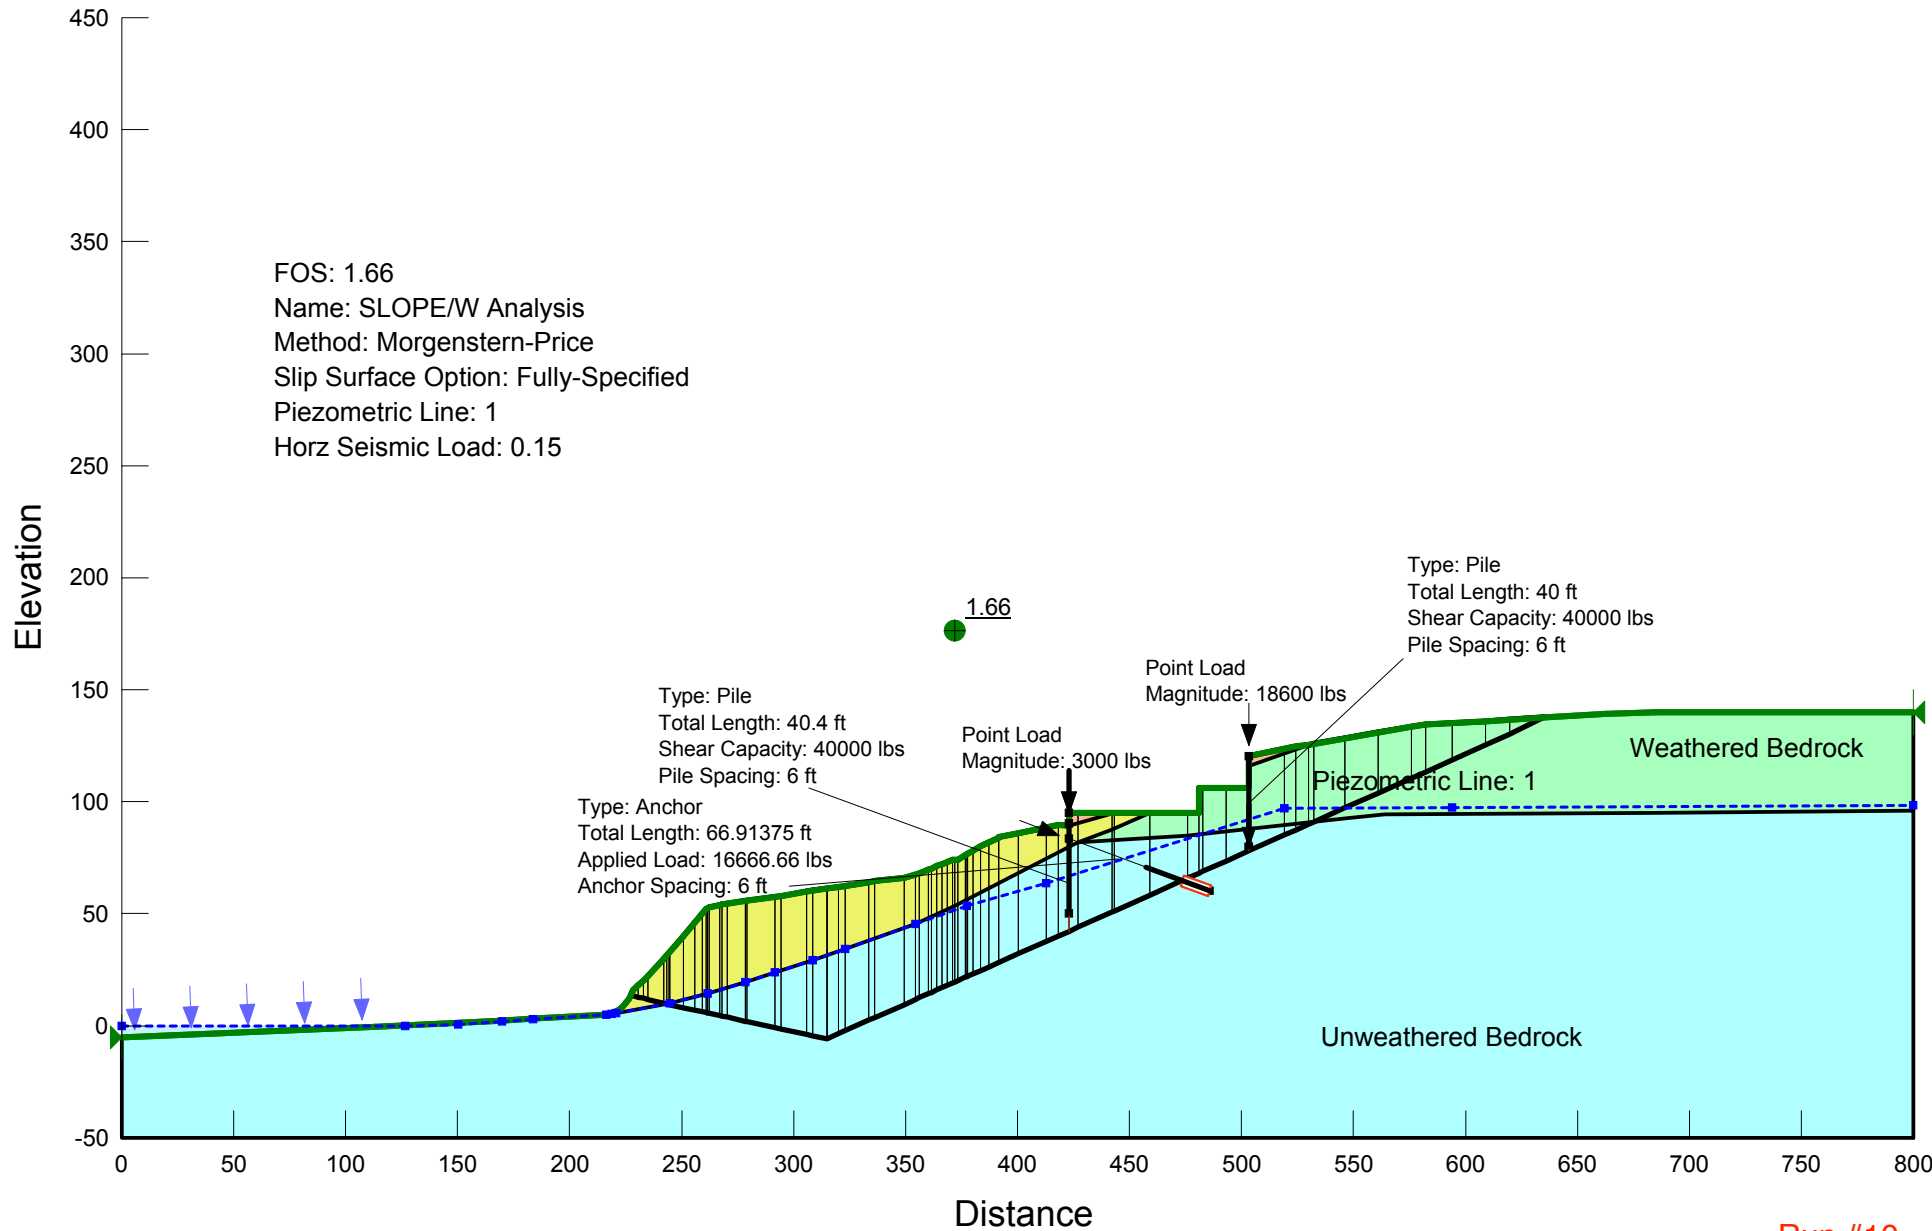
Name: Weathered Bedrock Unit Weight: 105 pcf Cohesion: 0 psf Phi: 25 ° Phi-Anisotropic Strength Fn.: Phi=45 (weathered)
Name: Unweathered Bedrock Unit Weight: 110 pcf Cohesion: 1 psf Phi: 32 ° C-Anisotropic Strength Fn.: X-bed Cohesion (Unweathered)=2000 Phi-Anisotropic Strength Fn.: Phi=40 (unweathered)
Name: Landslide Debris Unit Weight: 89 pcf Cohesion: 0 psf Phi: 19 °
Name: Af Unit Weight: 105 pcf Cohesion: 0 psf Phi: 25 °
